Region 9 Enforcement Division
75 Hawthorne Street
San Francisco, CA 94105

Inspection Date(s):	9/29/2015		
Time:	Entry: 10:00 am	Exit: 12:00pm	
Media:	Water		
Regulatory Program(s)	Clean Water Act NPDES /CAFO Dairy		
Company Name:	Legend Dairy Farms #2		
Facility or Site Name:			
Facility/Site Physical Location:	9811 Edison Avenue, Ontario		
Geographic Coordinates:			
Mailing address:	P.O. Box 2500, Chino, CA, 91708		
Facility/Site Contact:	Ron Peitersma	Title: Operator	
	Phone: [REDACTED]	Email:	
Facility/Site Identifier:	NPDES CAG018001 / Order R8-2013-0001, General waste discharge requirements for CAFOs (dairies and related facilities)		
NAICS:	112120 Dairy Cattle and Milk Production		
SIC:	0241 Dairy Farms		
Facility/Site Personnel Participating in Inspection:			
Name	Affiliation	Title	Email
Ron Peitersma	Legend Dairy	Operator	
EPA Inspector(s):			
John Tinger	EPA	Engineer	Tinger.John@EPA.gov
Federal/State/Tribal/Local Representatives:			
Edward Kashak	WRCB-R8	Engineering Geologist	ekashak@waterboards.ca.gov

SECTION I – INTRODUCTION

The facility has obtained coverage under NPDES CAG018001 / Order R8-2013-0001, General waste discharge requirements for CAFOs (dairies and relate

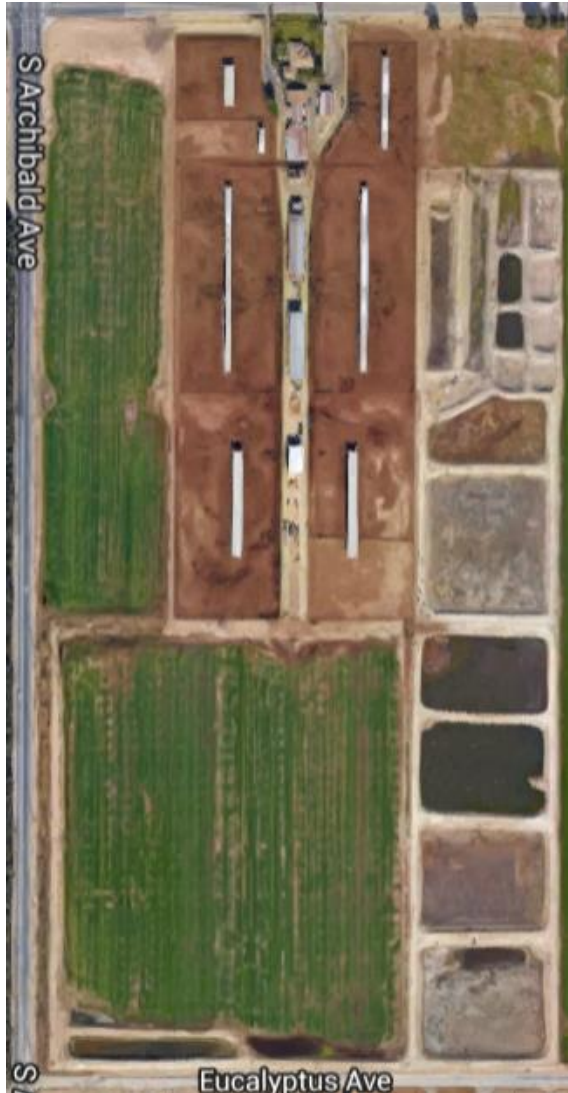
The facility has 16 ponds located on the eastern side of the dairy. (see photo 1) Washwater from the milk barn areas gravity flows to the northern ponds (photo 6), and washwater either gravity flows or is pumped to the ponds in series towards the spillway located at the southern end of the facility.

Photo 1: facility overview

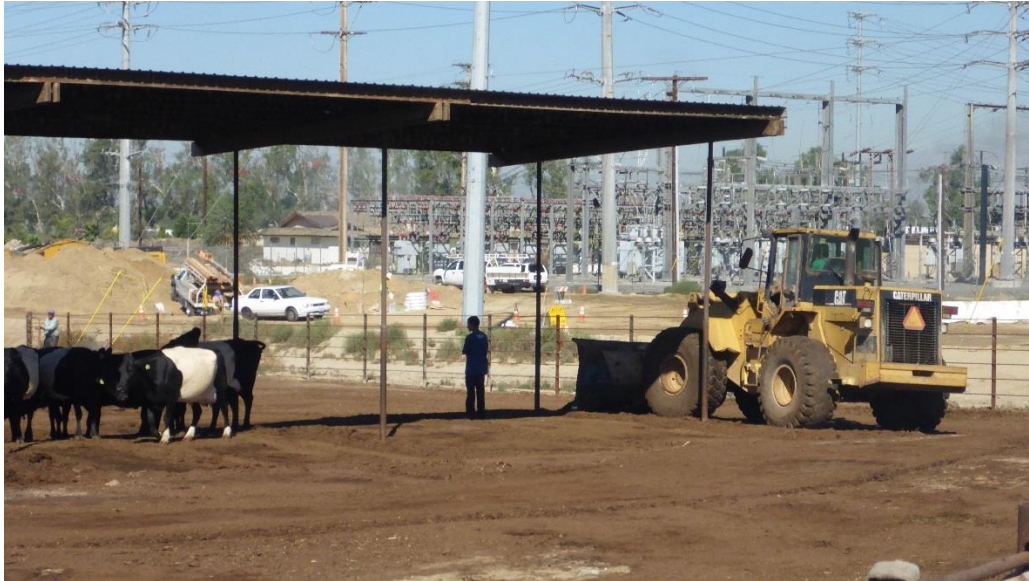
No issues noted. Corrals were being scraped and stockpiles of manure were being removed at time of inspection (see photo 1-2. Operator stated corrals would be continuously scrapped until the rainy season to remove manure. Manure did not appear to have been present for more than 180 days.

Photo 2: Corrals being scraped and manure being hauled off

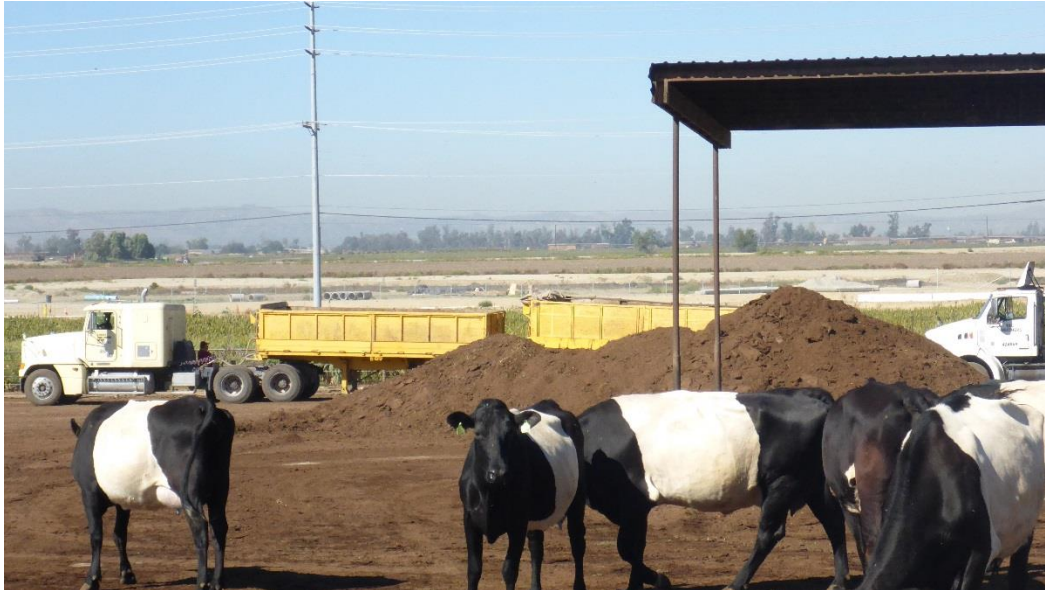
Photo 3: Corrals being scraped and manure being hauled off

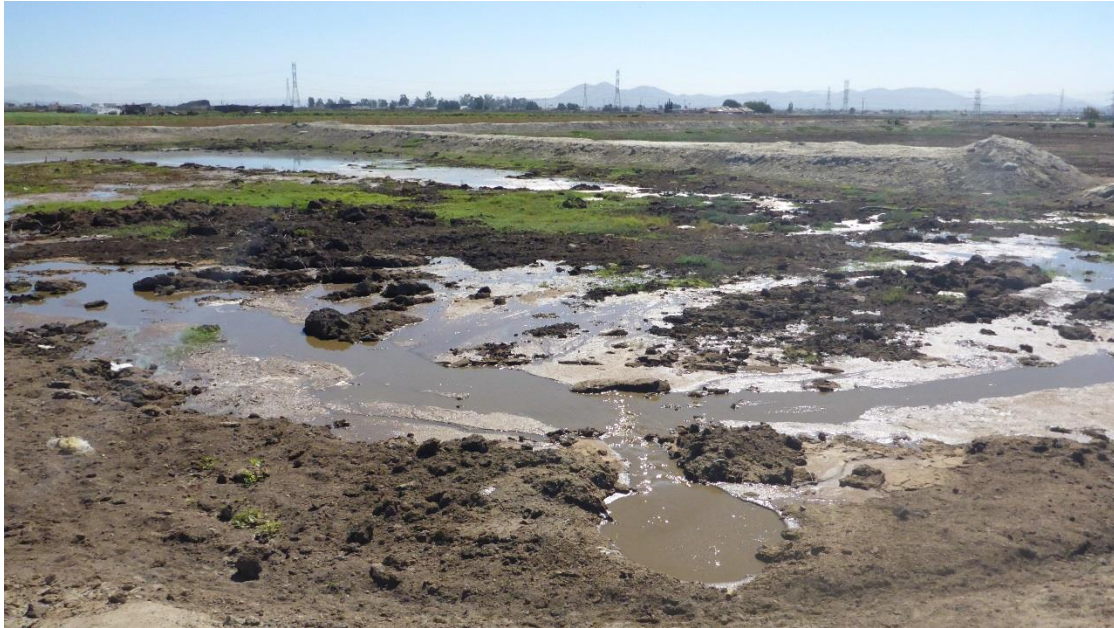
- Several ponds appeared to have excess solids with accumulation more than 2 feet deep. However, the pond network appeared to have sufficient storage capacity based on EWMP design, which includes a total of 16 ponds, many in series, and most of which did not have excess solids. The operator indicated the ponds will likely be scheduled for cleaning next year.

No evidence of significant rodent damage, erosion, or excess vegetation along berms was observed. Ponds generally clear of vegetation. Several ponds appeared to have excess amount of sediment buildup.

Photo 6: washwater flowing into pond. Build-up of accumulated sediments.

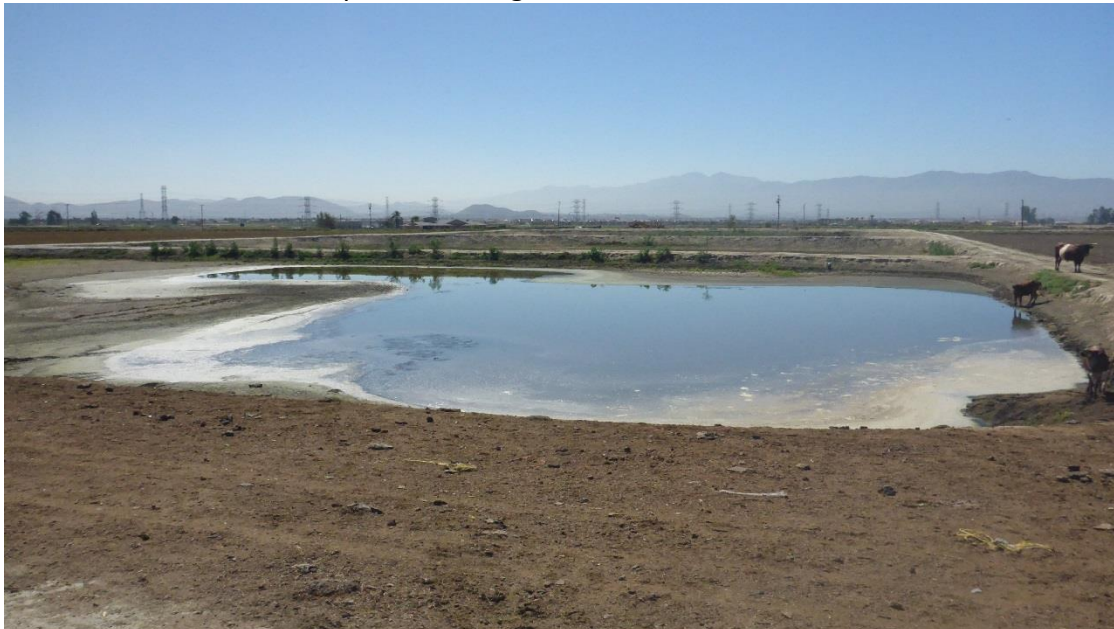
Photo 7: View of series of ponds looking south

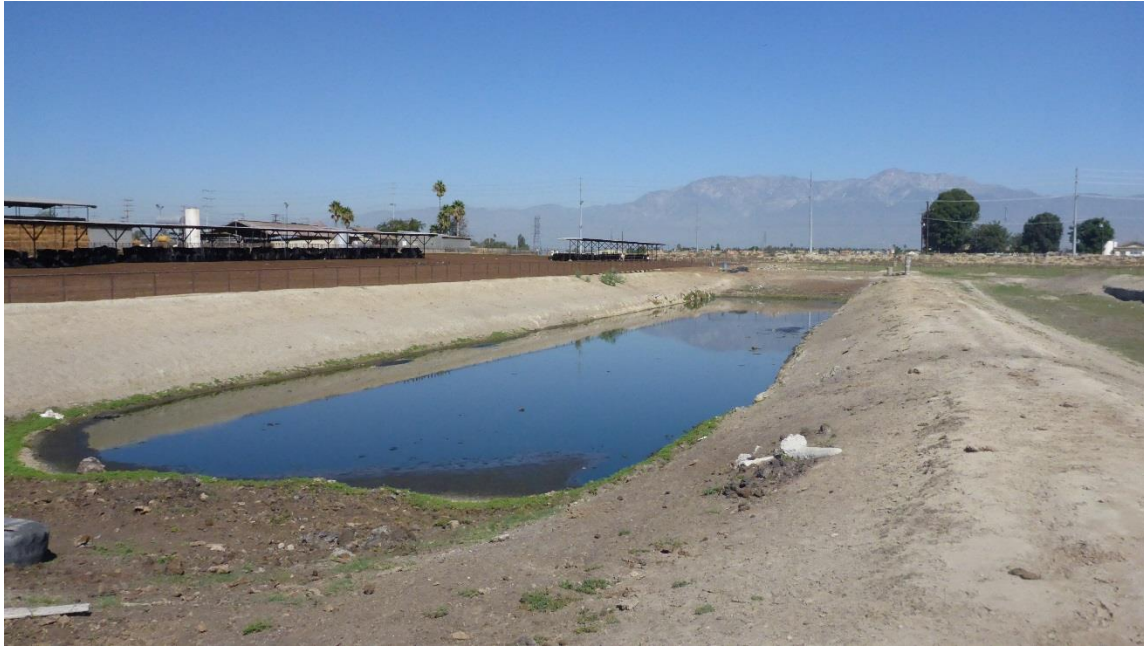
Photo 8: Northern pond; View looking northwest.

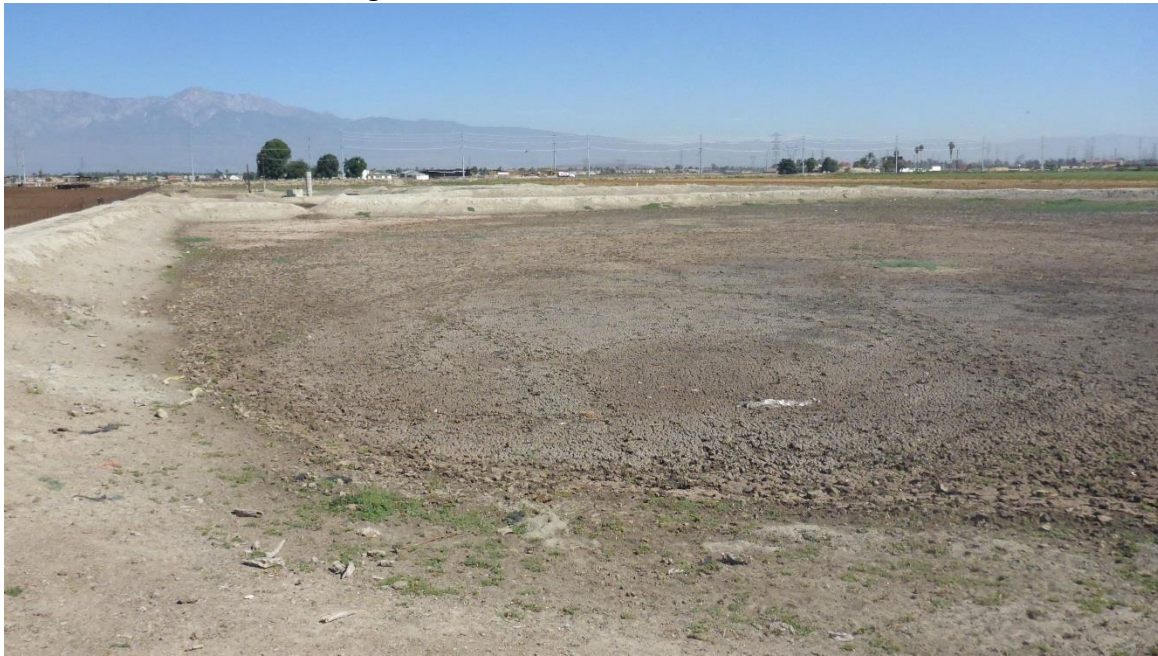
Photo 10: Pond view looking north

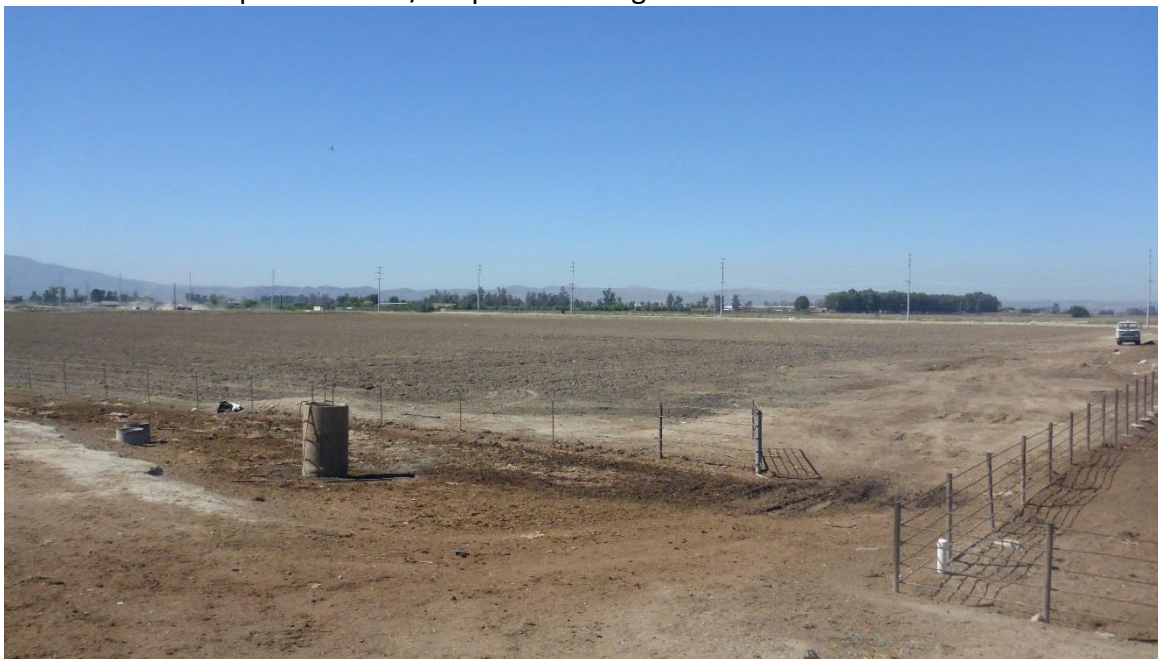
Stormwater flows in a southern direction. Stormwater from the corrals either flows to the northernmost ponds, or flows to the southern fields which are used a pasture land (photo 11). Operator stated that the pasture may be converted to croplands in future.

Photo 11: view of pasture area / cropland looking southwest

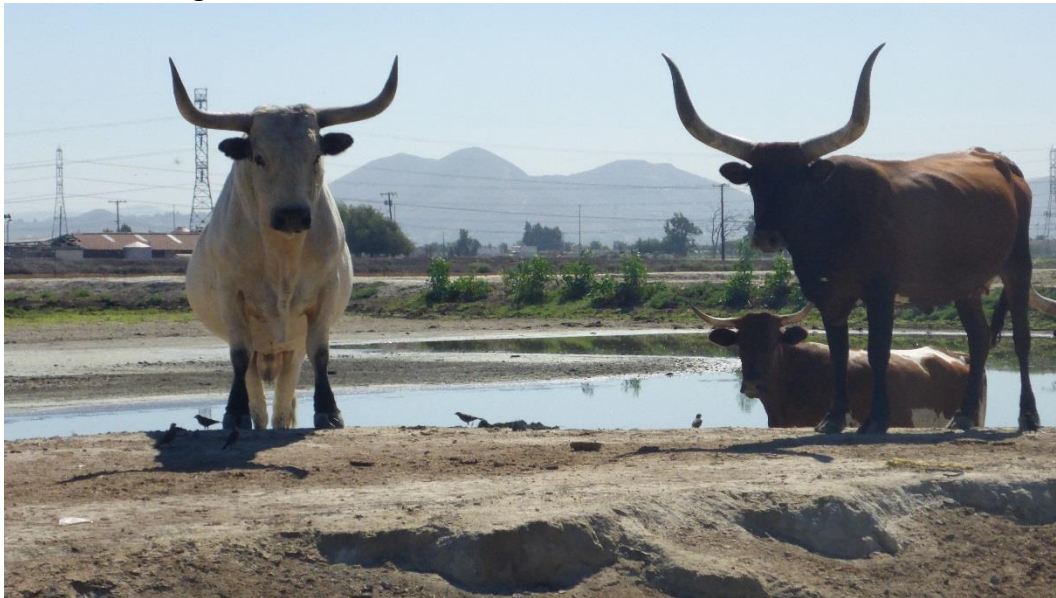
Operator indicated that berms were severely overgrown several years ago. The operator found the most effective way to manage the vegetation was by using longhorn cattle (see photo 11). The operator keeps 20 longhorn to control vegetation along the berms and lagoons and in the pasture.

Photo 12: Longhorns.
